## **Hurricane Ivan Storm Impact on Pipelines and Risers**

Kevin Gaudet  
Chevron Pipe Line Company

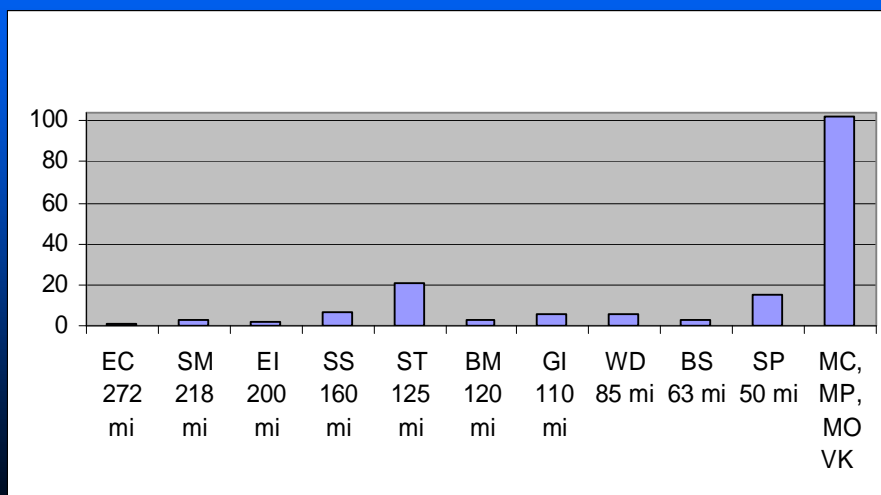
## Hurricane Ivan MMS Data - Locations of Damage to Pipelines and Risers

West Delta – 6 Reports – Approx. 85 mi. West  
Breton Sound – 3 Reports – Approx. 63 mi. West  
South Pass – 15 Reports – Approx. 50 mi. West  
Mississippi Canyon – 17 Reports – Direct Impact  
Main Pass – 73 Reports – Direct Impact  
Mobile Area – 5 Reports – Direct Impact  
Viosca Knoll – 7 Reports – Direct Impact

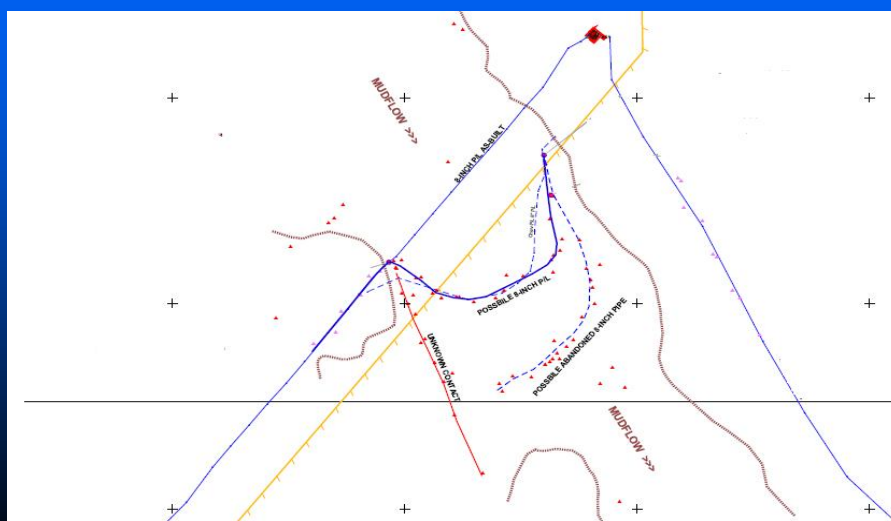
## Hurricane Ivan – Pipeline Mudslide Activity – 8" Pipeline

- 21 Reports of Damage to Pipelines and Risers due to mudslides.
- Reports of damage included:
  - Separation of break away joints (safety devices designed to separate at predetermined loads).
  - Severed pipelines.
  - Pipelines moving out of the Right of Way.
  - Risers and Pipelines Damaged due to toppled platforms.
